Subject: Boeing Submission for Asiana Airlines (AAR) 777-200ER HL7742  
Landing Accident at San Francisco – 6 July 2013

**Asiana 777-200ER – HL7742  
Landing Accident at San Francisco  
6 July 2013**

**The Boeing Company  
17 March 2014**

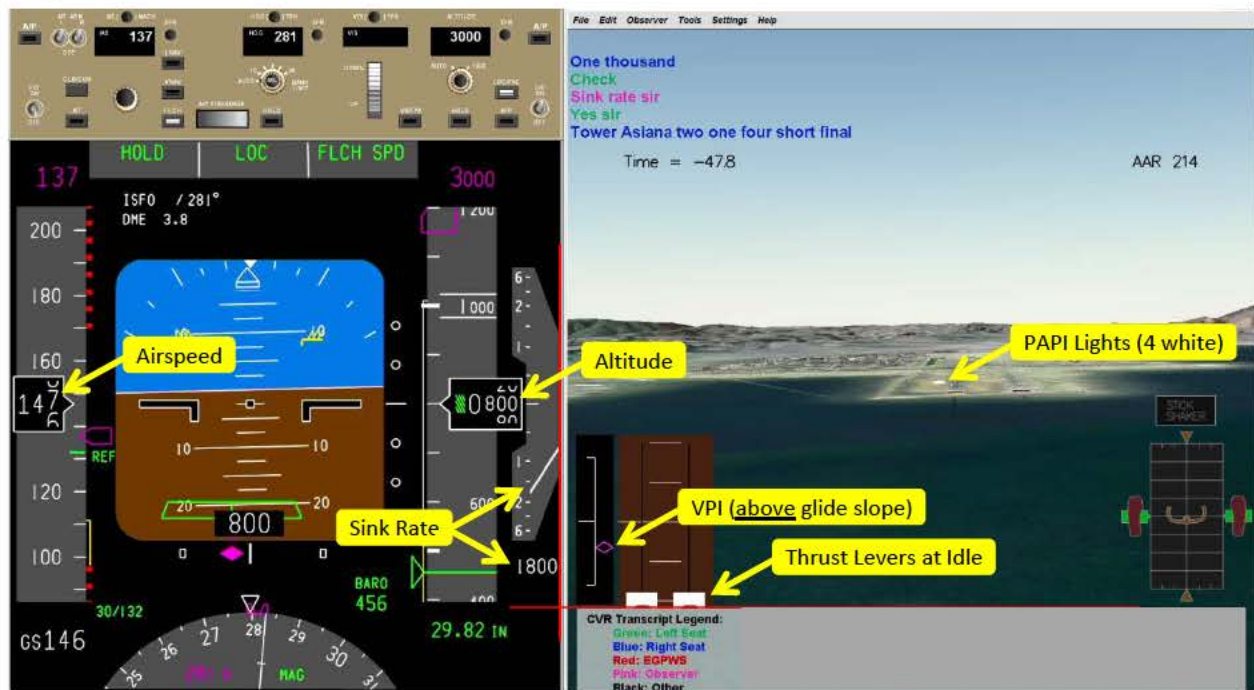
Snapshot of Backdrive Animation at 800 feet:

Discussion: As the aircraft descended through 900 feet to about 700 feet, the recorded sink rate peaked at 1,776 feet/minute,<sup>20</sup> in excess of the 1,000 feet/minute limit set by Asiana's Flight Operations Manual for descent rates below 1,000 feet.<sup>21</sup> The CVR recorded that the observer First Officer called out "*sink rate*" to alert the PF and PM that the sink rate was excessive. Despite this excessive descent rate, the aircraft was still well above the glideslope. Four white PAPI lights were visible, and the VPI showed the airplane was high. Further, the aircraft's speed was 9 knots above the MCP selected speed, even though the throttles remained at the idle stops.

Analysis: This represents another opportunity to recognize the issue of being high on short final and abort the landing.

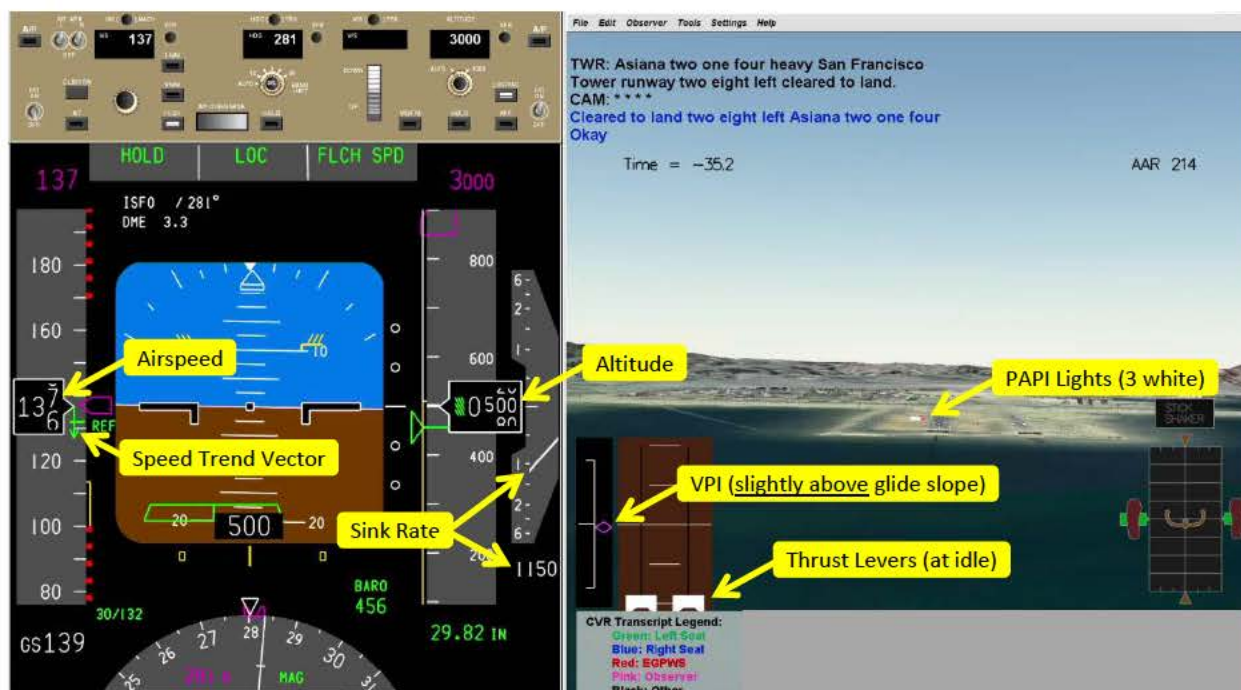
Snapshot of Backdrive Animation at 500 feet:

Discussion: This is the initial point in a visual approach (500 feet) where the Stabilized Approach Criteria began to apply for visual meteorological conditions. Table 2 (page 16) shows a summary of how the approach, at this point, compared to the Stabilized Approach Criteria. Given the failure to meet the Stabilized Approach Criteria, Asiana’s policies required the crew to conduct a go-around.

Asiana procedures require the PM to call out “five hundred” when the aircraft reaches 500 feet. At that point the PF must respond by either calling out “landing” or “stabilized” or executing a go-around.<sup>22</sup> The CVR did not record any discussion of the approach being stabilized. Nor did it record that either pilot made the callouts required by Asiana procedures. At 500 feet, the approach did not meet the Stabilized Approach Criteria and a go-around should have been initiated.

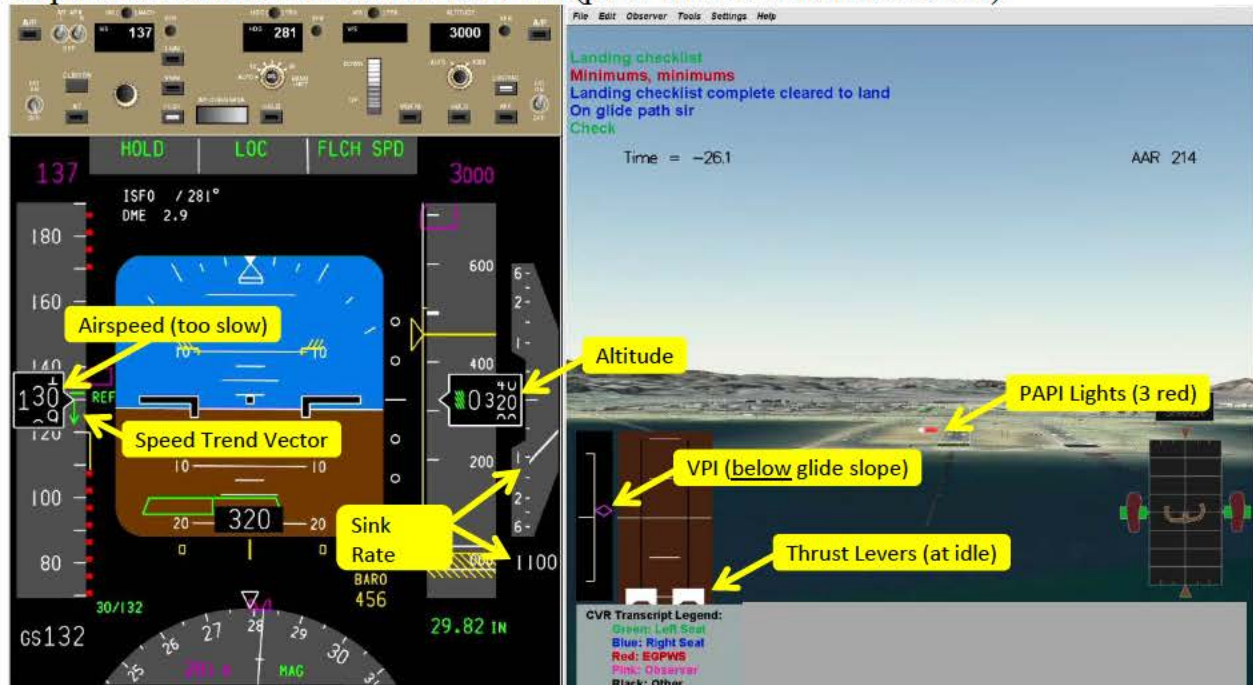
Snapshot of Backdrive Animation at 320 feet (point where PAPI showed 3 Red):

Discussion: About three seconds prior to the PAPI showing 3 Red, the PM said “*on glide path sir*” and the PF responded “*check.*” The PAPI then turned to 3 Red (see Appendix 1, Plot 5). The approach was progressively becoming more unstable: the thrust setting was not correct, airspeed was low and decelerating, and sink rate remained excessive (see Table 2, page 16). There was no recognition or discussion on the CVR of any of these issues.

During the NTSB public hearing, Asiana’s 777 Chief Pilot stated that, under Asiana’s policies, if the flight crew sees 3 red PAPI lights, the PM should call out that the aircraft was low, and the PF should take immediate action.<sup>23</sup> Further, Asiana’s policy expressly states that “...an approach that becomes unstabilised below ... 500 feet AFE in VMC requires an immediate go-around.”<sup>24</sup>

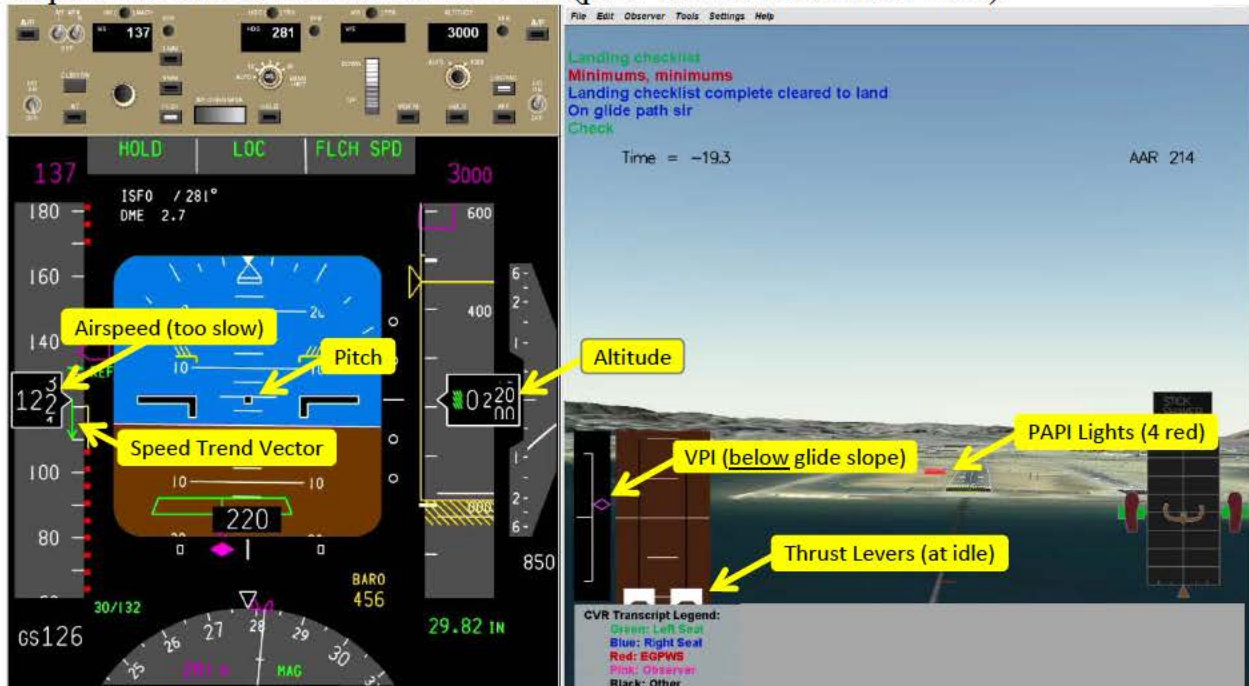
Snapshot of Backdrive Animation at 220 feet (point where PAPI showed 4 Red):

Discussion: At approximately 220 feet, the PAPI goes to 4 Red and the approach is more unstable, as shown in Table 2 (page 16). The PM said “*it's low,*” and the PF acknowledged with “*yeah*”. But the crew neither called for a go-around nor initiated one. None of the three pilots on the flight deck said anything about the throttles being at the idle stops or airspeed, which was 15 knots below the MCP selected speed. In his second interview, the PF said “he was worrying about the PAPI turning to four red lights because that meant he would fail his flight, and he would be very embarrassed if that occurred. He added that four red is a very dangerous situation to a pilot.”<sup>25</sup> Apparently recognizing that the airplane was below the glide path, the FDR data show the PF applied an unusual amount of aft column to pitch the airplane up.

During the NTSB public hearing, Asiana’s 777 Chief Pilot stated that, under Asiana’s policies, if a flight crew sees four red PAPI lights, they are required to perform an immediate go-around.<sup>26</sup>

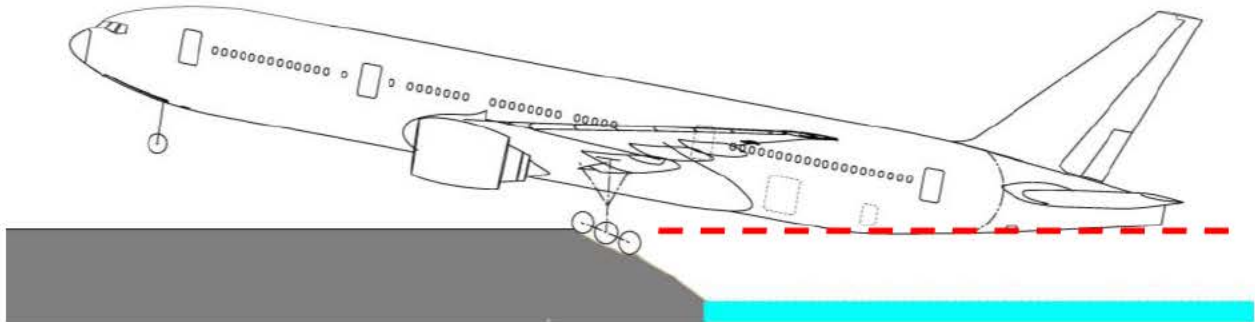
Estimated aircraft position at impact with the seawall

Airspeed at impact was about 105 knots, and pitch attitude was 11-12 degrees. At impact, the control column was at the full aft stop, with a total of over 100 pounds of column force being exerted by both pilots combined.

The lowest recorded airspeed during the approach was 103 knots, which was 34 knots below the MCP selected airspeed of 137 knots. 137 knots is  $V_{REF} + 5$  knots, which was the correct airspeed for the approach.
