# Moving Forward With the 787

**Mike Sinnett**

Vice President and Chief Project Engineer

*March 15, 2013*

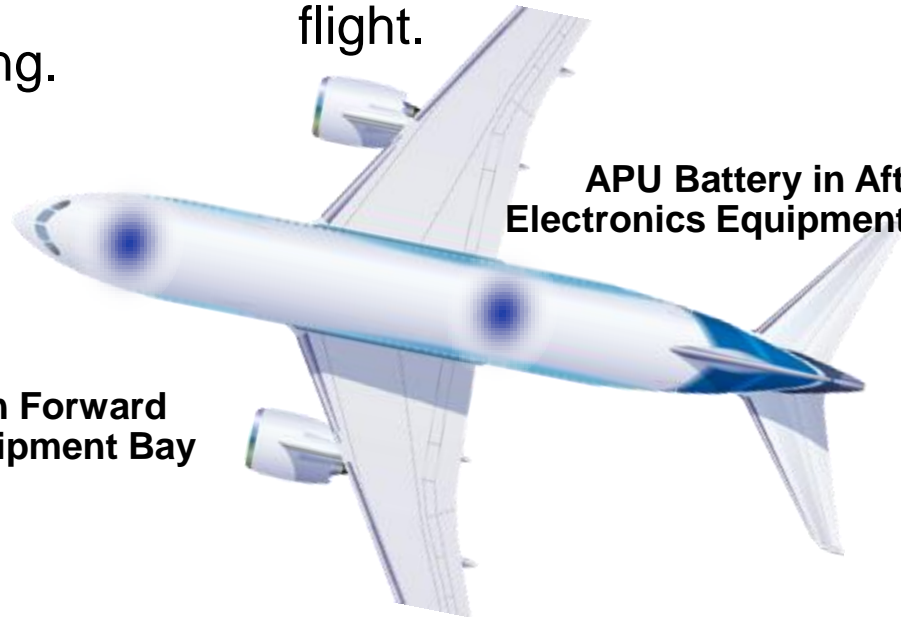
- Ground maintenance operations:
  - ❖ Refueling.
  - ❖ Brake power while towing.
  - ❖ Navigation lights while towing.
- Backup power.

- APU start
  - ❖ APU provides ground power and serves as backup power in flight.

Main Battery in Forward  
Electronics Equipment Bay

APU Battery in Aft  
Electronics Equipment Bay

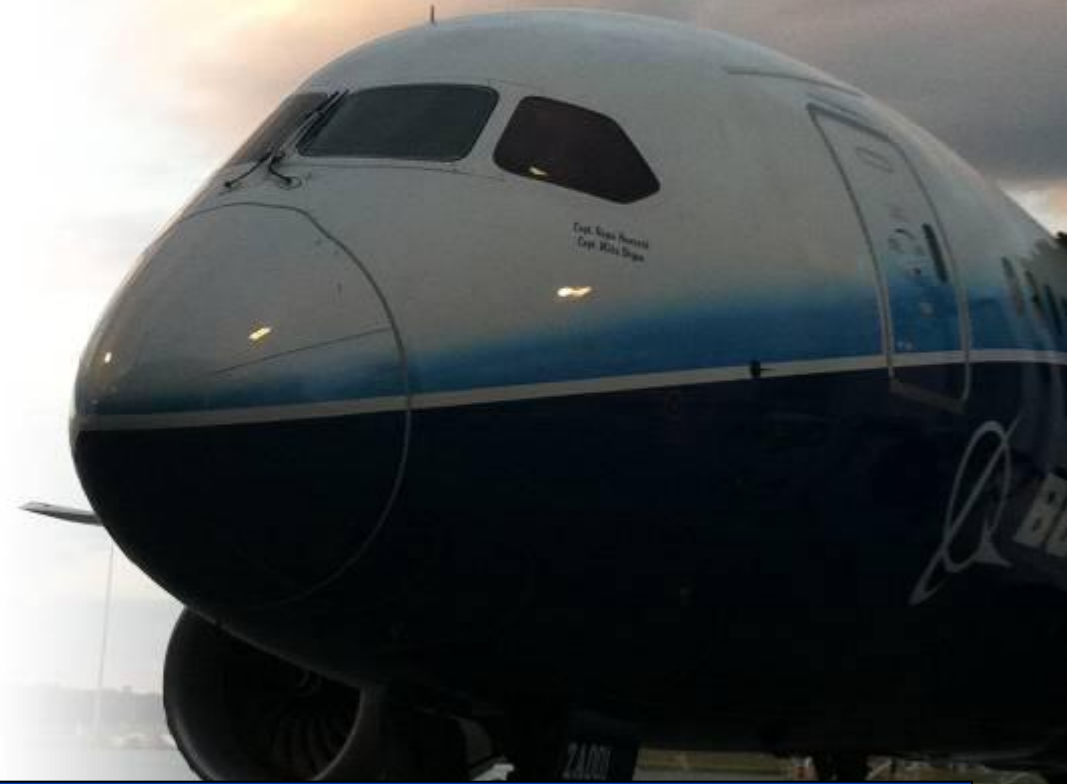
# Lithium-Ion Provides an Advantage

- High power for ground operations
- Less weight / less volume
- Improved charging characteristics
- No memory effect
- Improved storage life

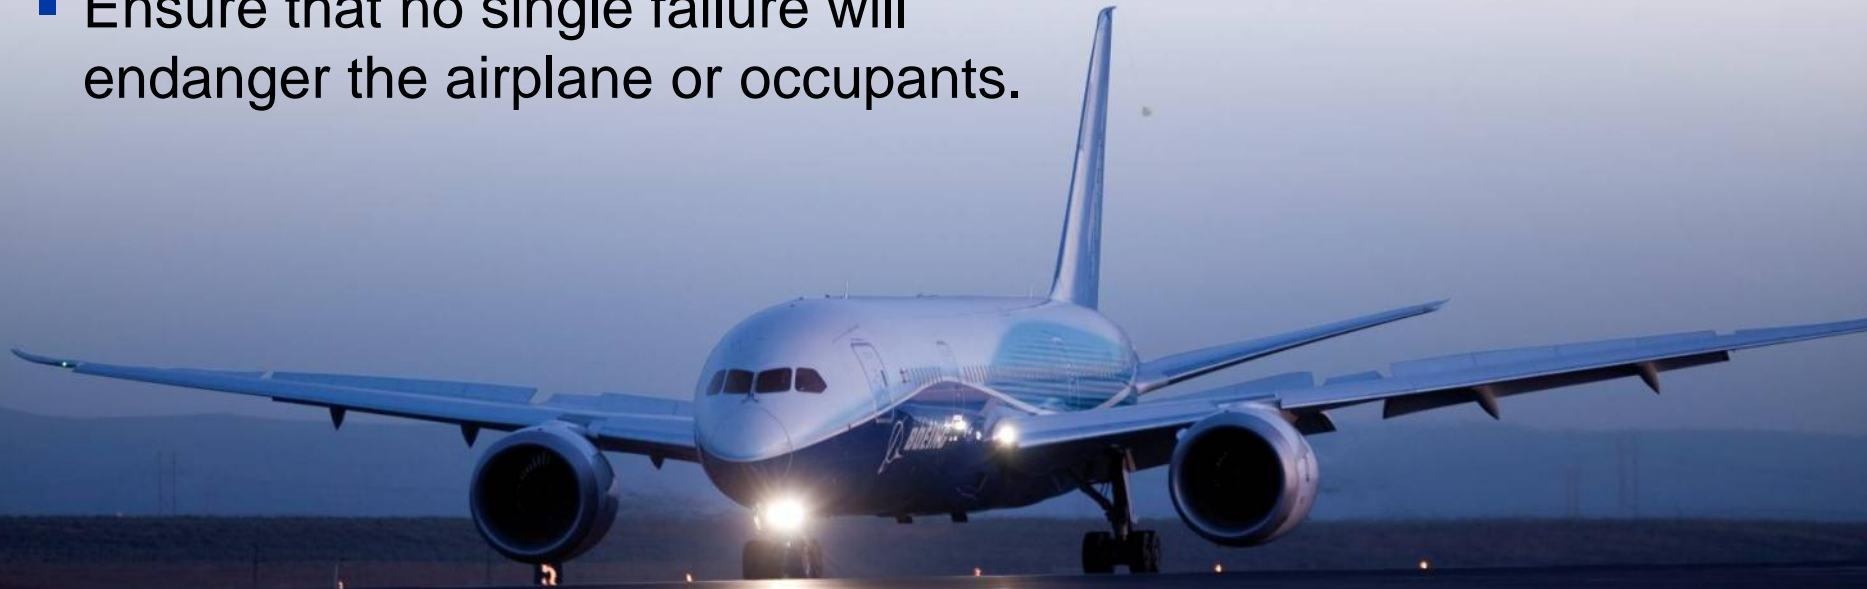
# System Design Objectives

- Prevent failure but be capable of handling one if it occurs.
- Redundancy provides multiple layers of protection.
- Ensure that no single failure will endanger the airplane or occupants.

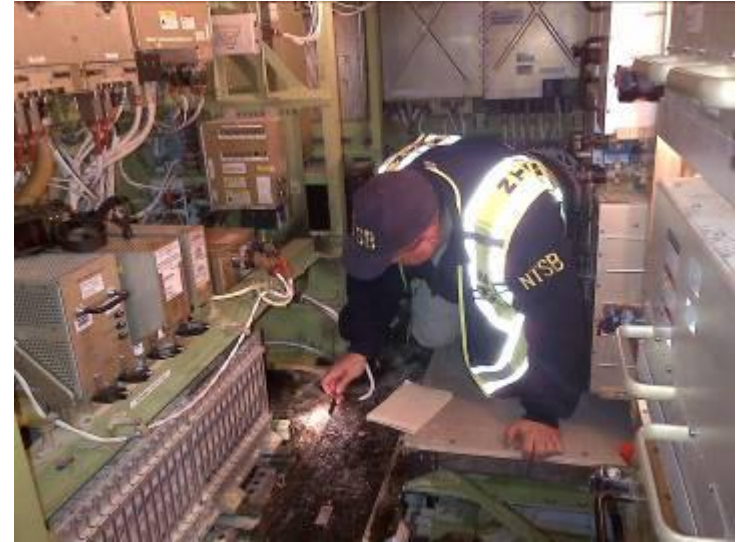
- No major airplane structure was damaged
- Minor damage within 20 inches of battery
- Two three-inch flames at connector outside of the battery box (Boston)
- No fire in Takamatsu event
- Cells vented, which is a protective feature of the battery
- Airplane systems functioned as intended

*Electrical equipment bay –  
Boston event*

**Damage Limited to Battery Area and Function**

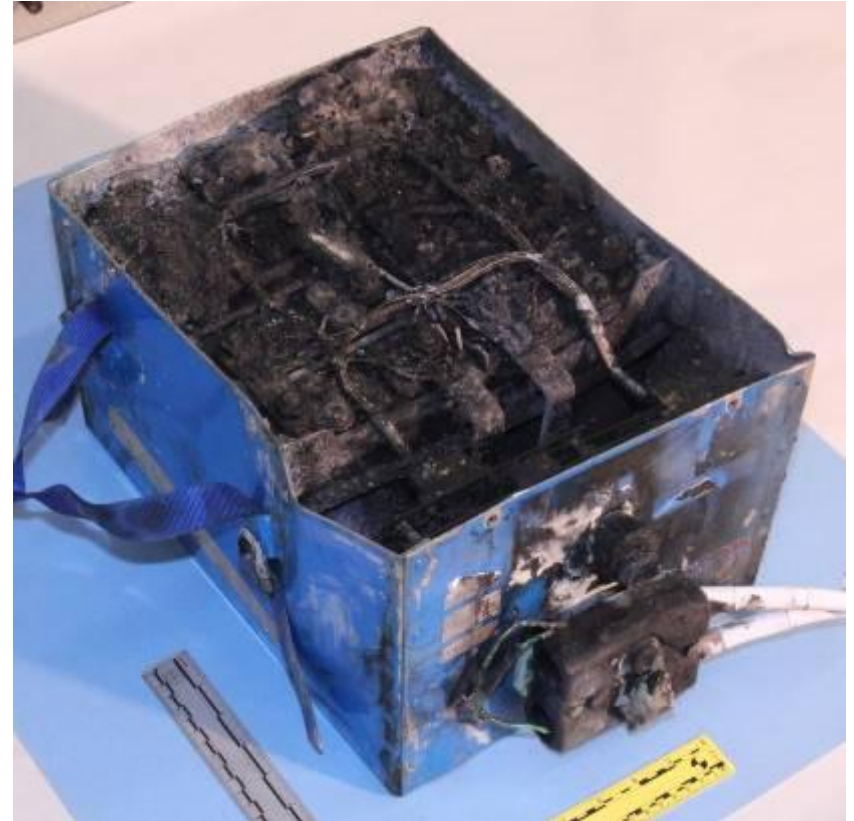
- The only possible cause for thermal runaway at an airplane level is overcharging.
- The 787 has four independent protections against overcharging
- Following detailed review no evidence of overcharging was found in either event.

*Boston battery*

## Propagation of Overheating and Venting

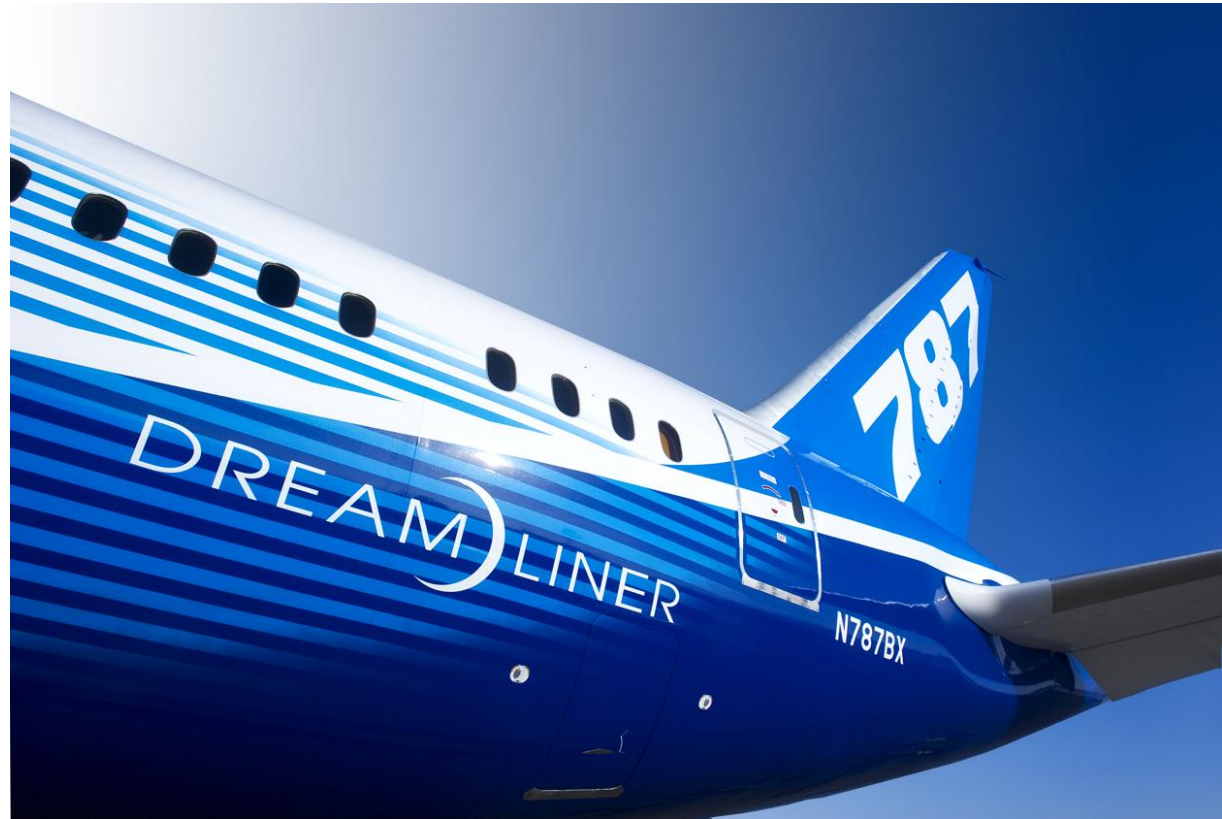
# Three Layers of Protection

- Prevent initiation of event
- Prevent propagation of event
- Prevent impact to airplane

**Causal Factors Addressed**

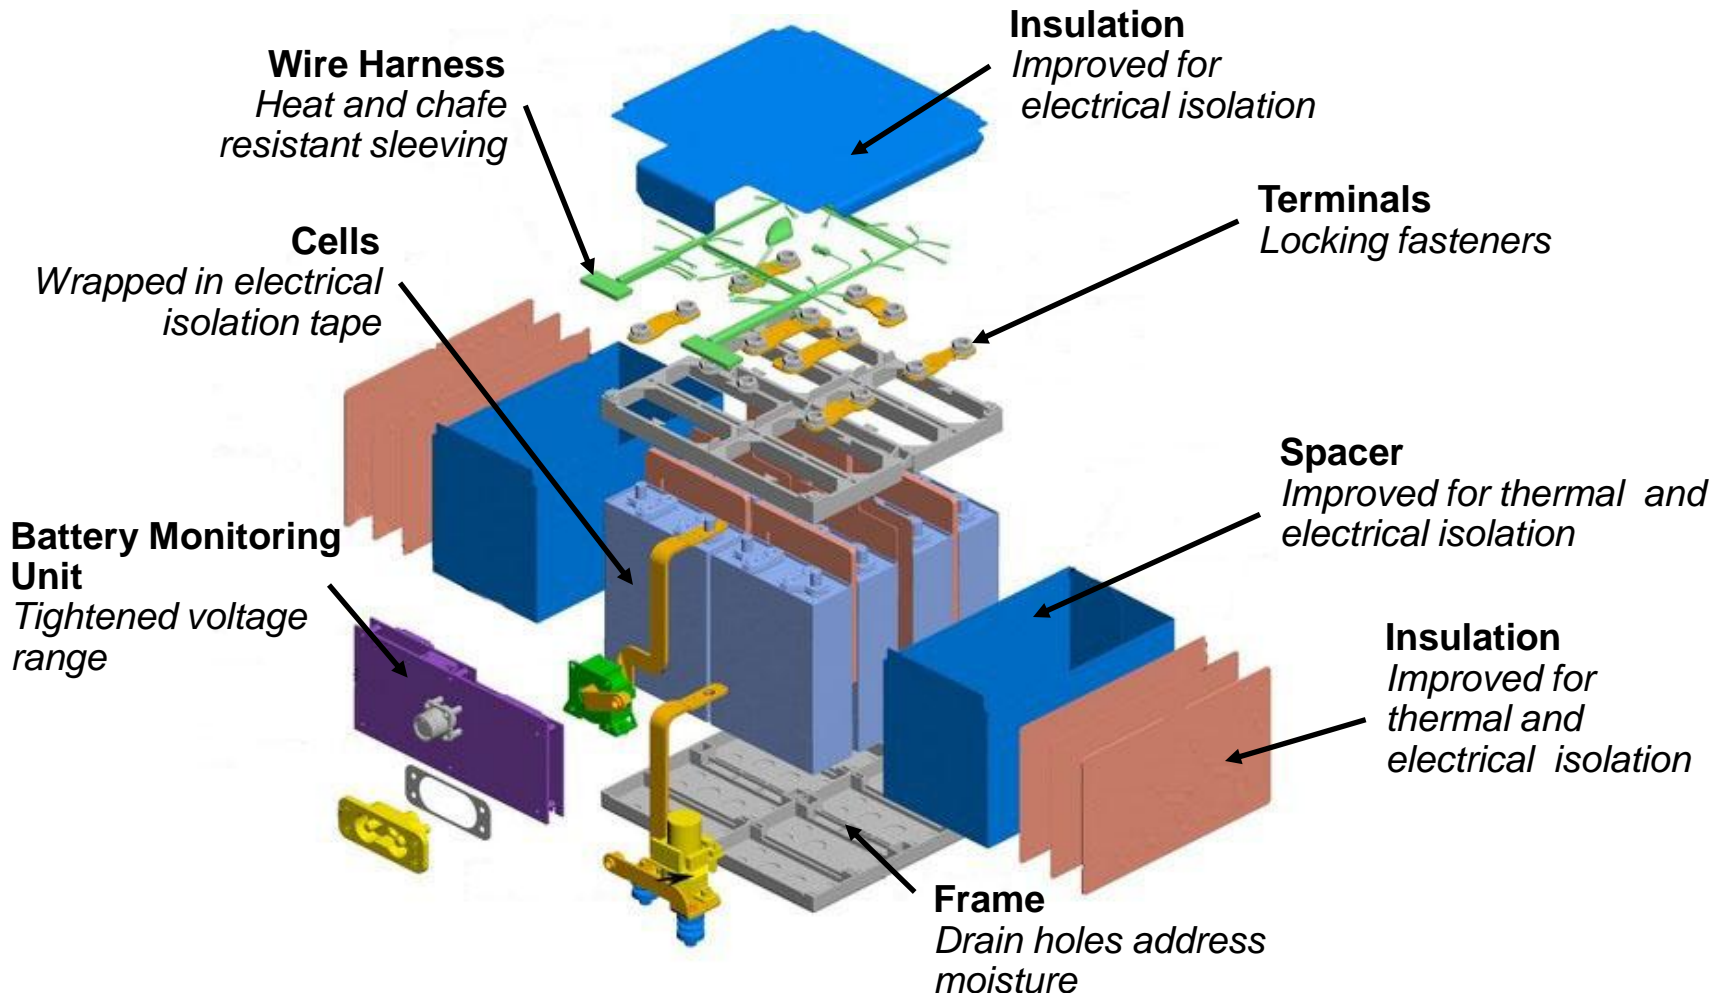
# Comprehensive Set of Solutions: Battery

**Prevent Issues, Reduce Impact of Issues**

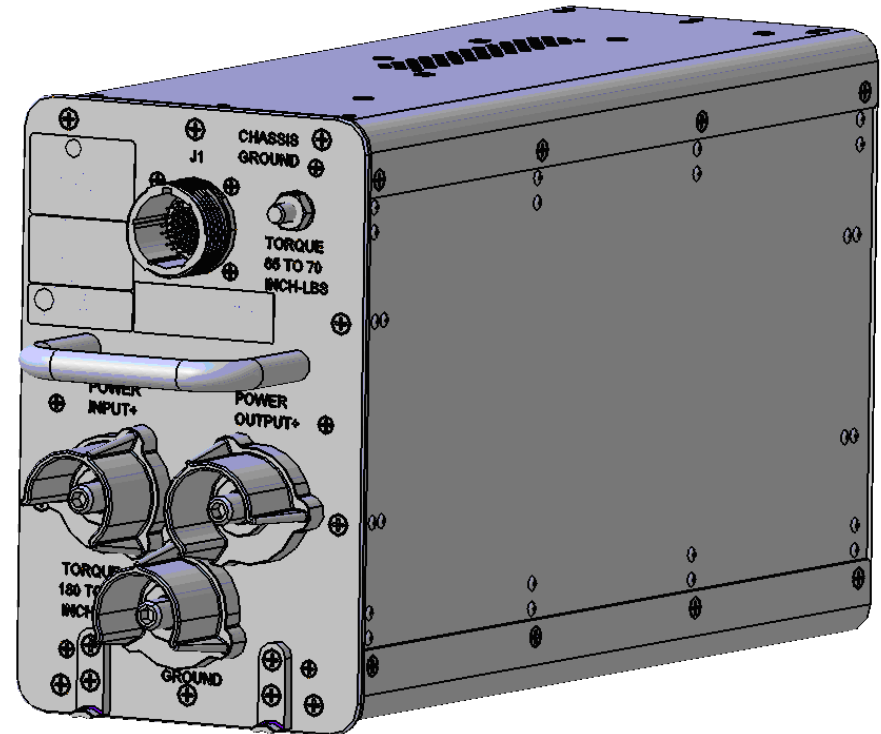
# Comprehensive Set of Solutions: Charger

- Reduced maximum charging levels
- Increased minimum charging levels = increased maximum discharge level
- Softened charging sequence

**Decreases Workload on the Battery**

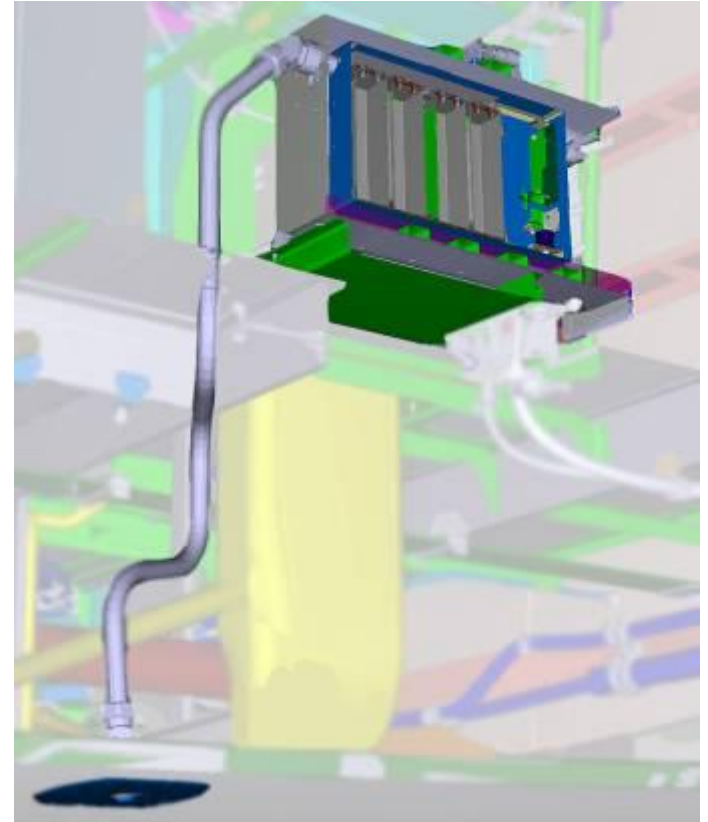
- Eliminates potential for fire
- Vented electrolyte released safely within enclosure
- Heat and pressure released safely within enclosure
- Dedicated vent line
- All vapors and odors vented immediately overboard

*Enclosure and vent line*

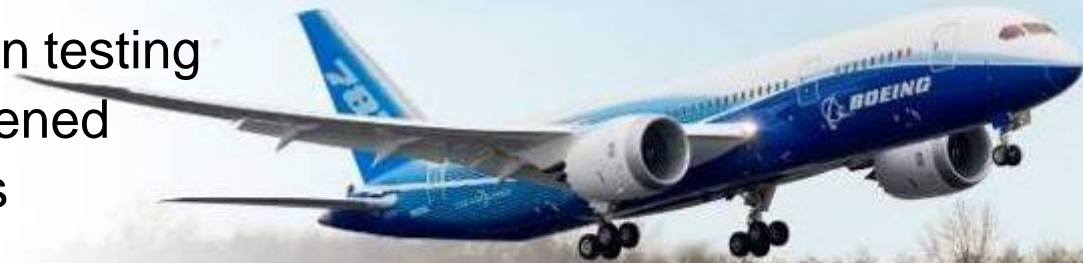
# Safeguarding Your 787 Flight

- Prevent Initiation
  - ❖ Enhanced manufacturing controls
  - ❖ Enhanced post-production testing
  - ❖ Protection limits strengthened
  - ❖ Improved design features
- Prevent Propagation
  - ❖ Design changes increase cell isolation (thermal and electrical)
  - ❖ Vapors controlled by dedicated vent system
  - ❖ Vapors immediately released overboard
- Prevent impact to airplane
  - ❖ Enclosure prevents fire from occurring
