Subject: Boeing Submission for Asiana Airlines (AAR) 777-200ER HL7742  
Landing Accident at San Francisco – 6 July 2013

**Asiana 777-200ER – HL7742  
Landing Accident at San Francisco  
6 July 2013**

**The Boeing Company  
17 March 2014**

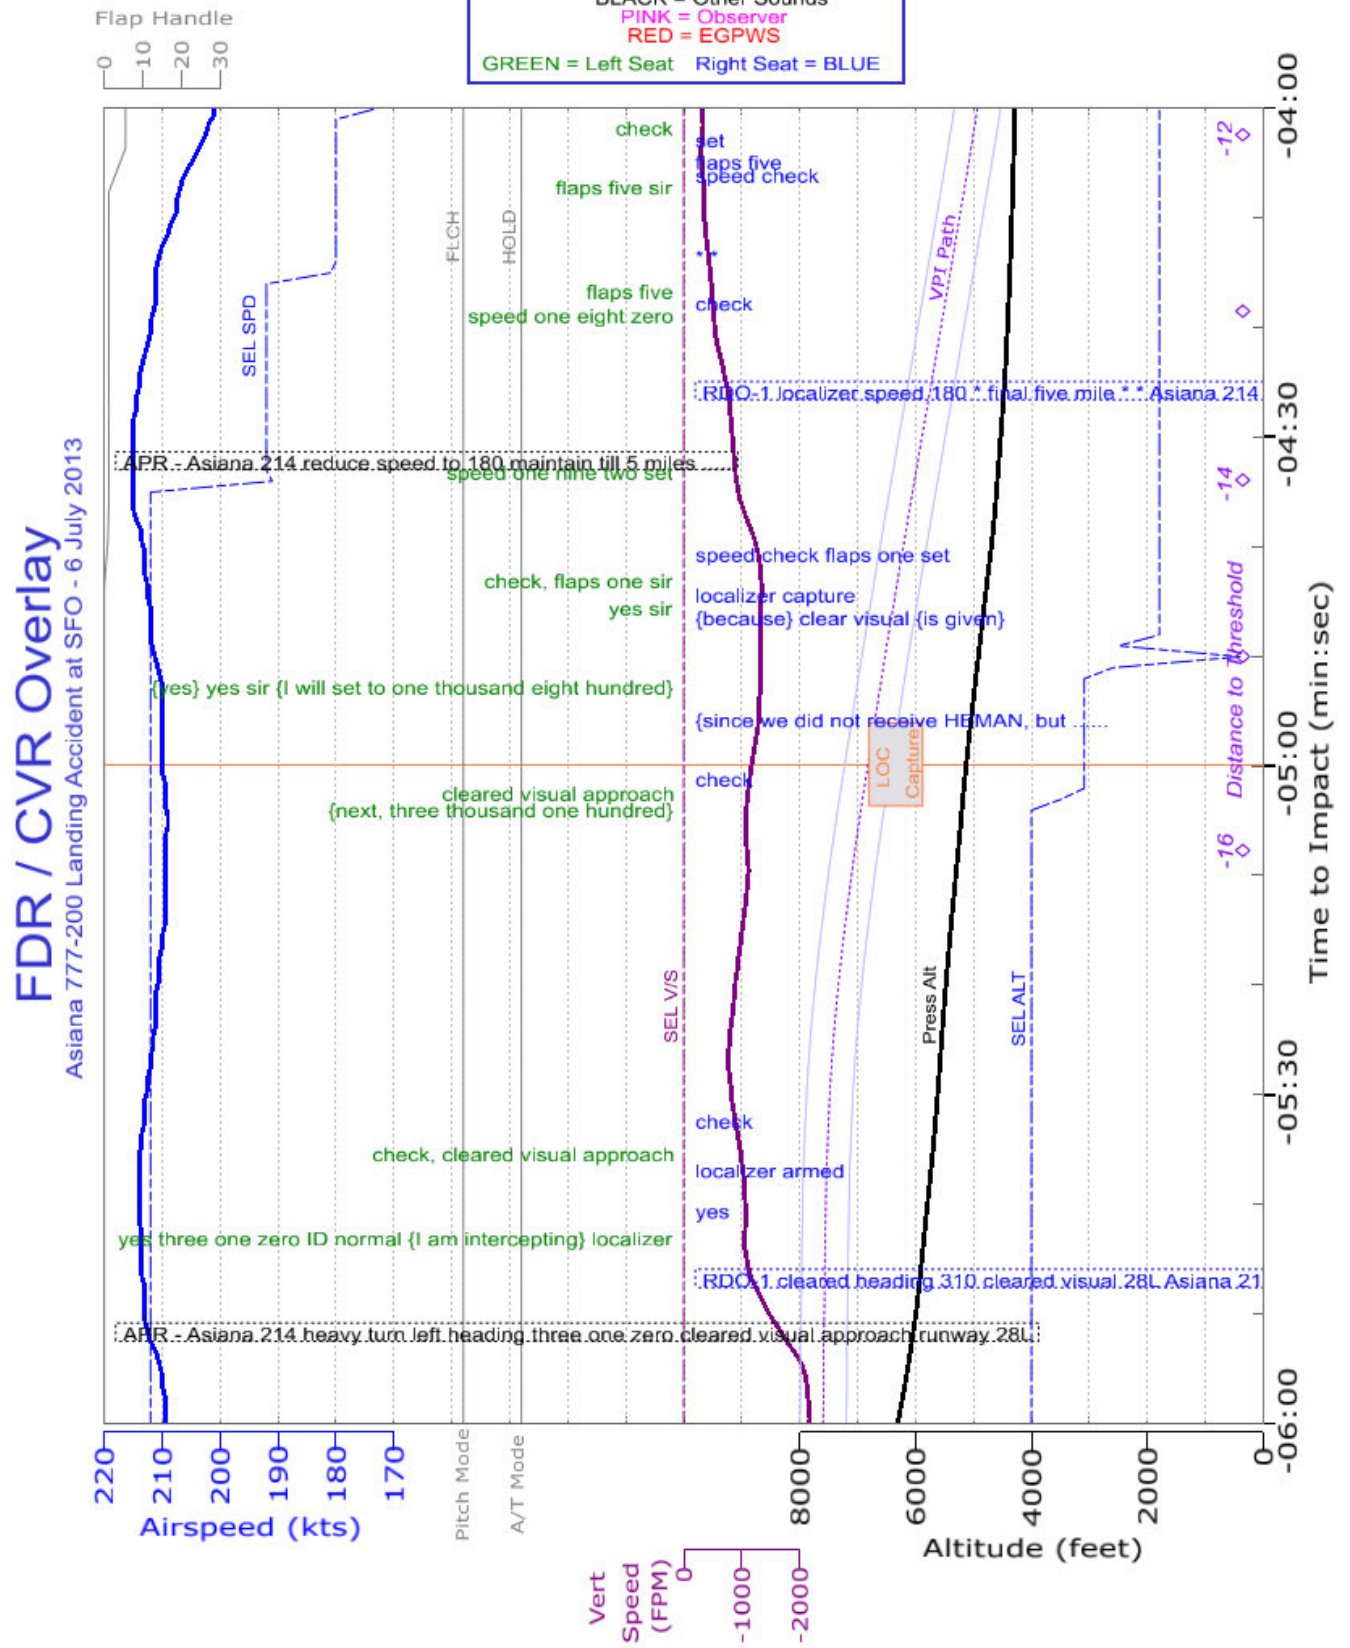
### Plot 2 – FDR/CVR Overlay

#### Initial Approach – LOC Capture

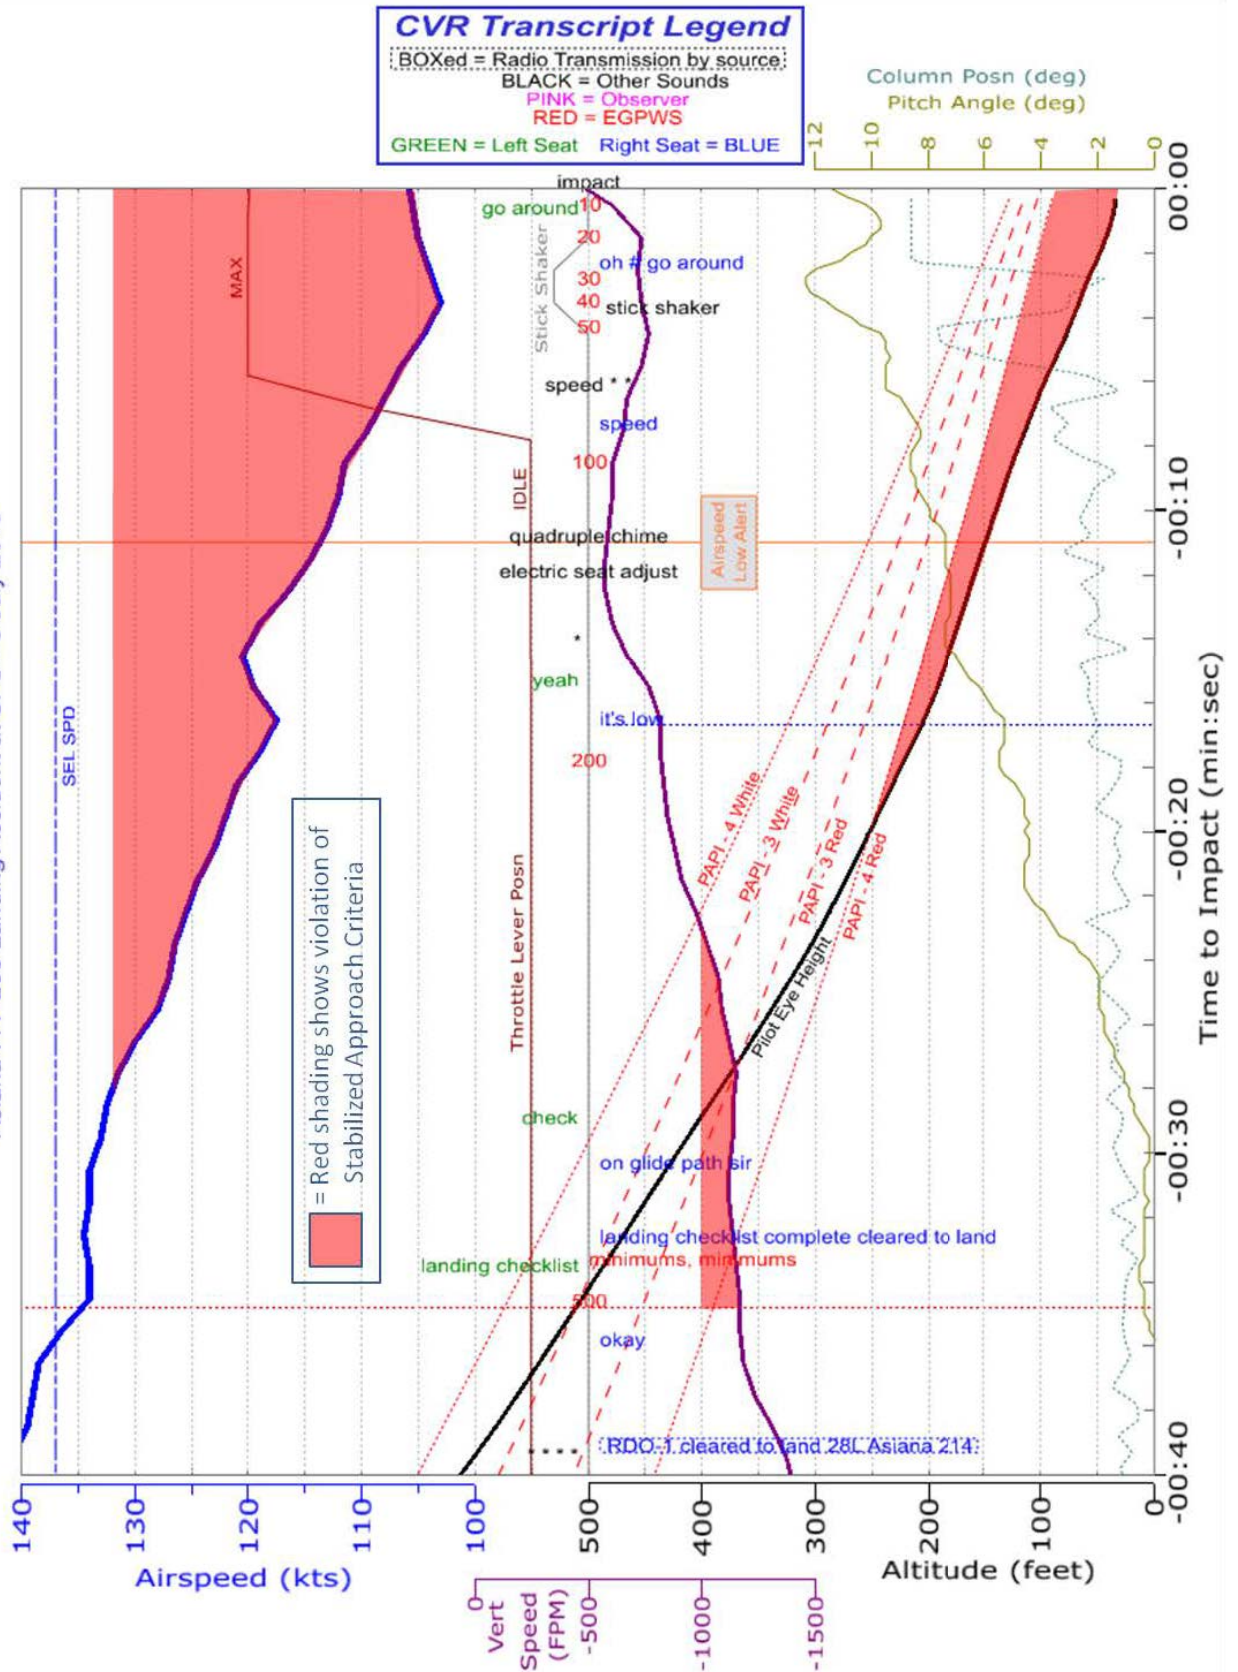
Plot 5 – FDR/CVR Overlay  
Final Approach from 500 feet

- Below 500 feet, there were numerous cues - visual and tactile - provided to the flight crew that showed the aircraft's speed was decaying, the aircraft's thrust setting was incorrect, and the aircraft was increasingly below the glide path. These cues pointed to an increasingly unstable approach, which should also have caused the crew to initiate a go-around.

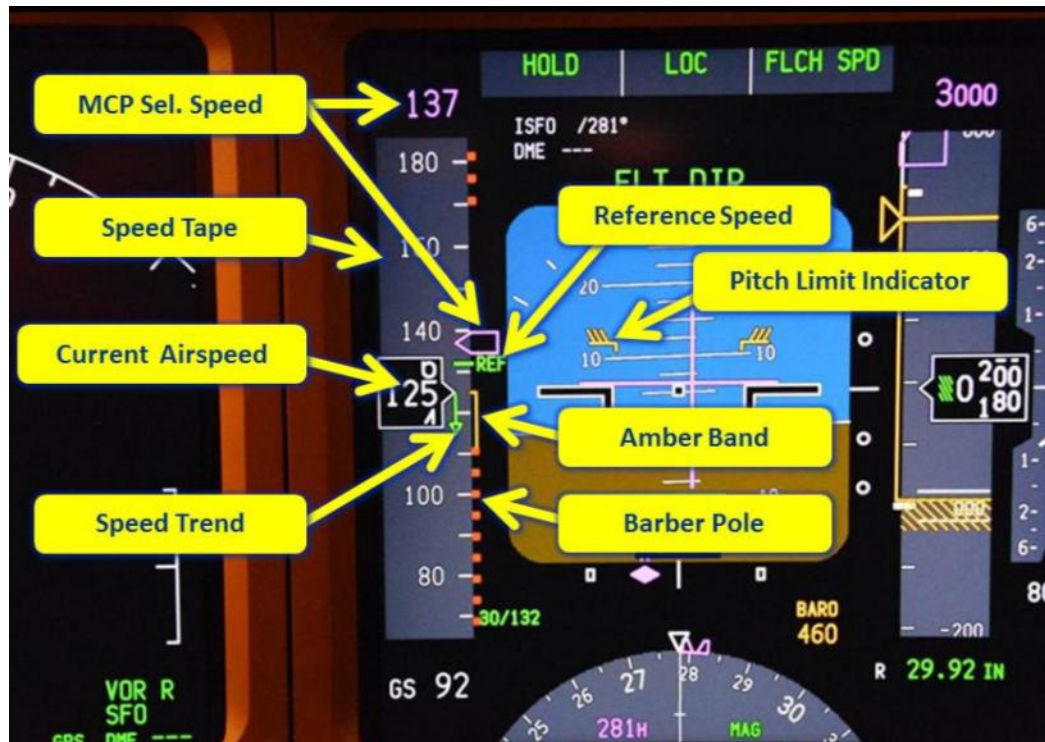
## Airspeed Cues (continued)

- The MCP selected speed, which appears both as digits and as a “bug” on the speed tape.
- The speed tape, which moves up and down as airspeed changes providing pilots with a sense of how quickly speed is changing.
- The current airspeed displayed with rolling digits, provides a sense of rate of change of speed.
- The speed trend vector, which indicates what the airspeed will be in 10 seconds.
- V<sub>REF</sub> “bug” on the speed tape, indicating the V<sub>REF</sub> speed.
- The amber band, where top of amber band is minimum maneuvering speed, bottom of amber band is at the barber pole.
- The “barber pole,” indicating the stick shaker activation speed.
- The pitch limit indicator, indicating the pitch angle at which stick shaker will activate.<sup>72</sup>

In addition to the visual cues that the speed was decreasing, the aircraft also provided the crew with tactile cues that airspeed was decreasing below the minimum maneuvering speed. Stabilizer trim is inhibited when airspeed falls below the top of the amber band, which represents minimum maneuvering speed. Additionally, the force required to pull back on the column begins to increase considerably the slower the aircraft becomes.<sup>73</sup> All of these features are designed to provide a tactile cue that the airspeed is dropping below the minimum maneuvering speed. Prior to impact, the force exerted by the PF to increase the aircraft’s pitch was steadily increasing. At impact, the control column was at the full aft stop, with a total of over 100 pounds of column force being applied by both pilots combined.<sup>74</sup>
